Report V1.0

# Engineer's Foundation Evaluation

On 8/8/2026 a foundation evaluation was performed at the property located at address 5433 Kennerly Rd, Jacksonville, FL, 32207, which consists of a 1540 square-foot single family attached structure built in 1972 (54 years old) with a slab on grade foundation.

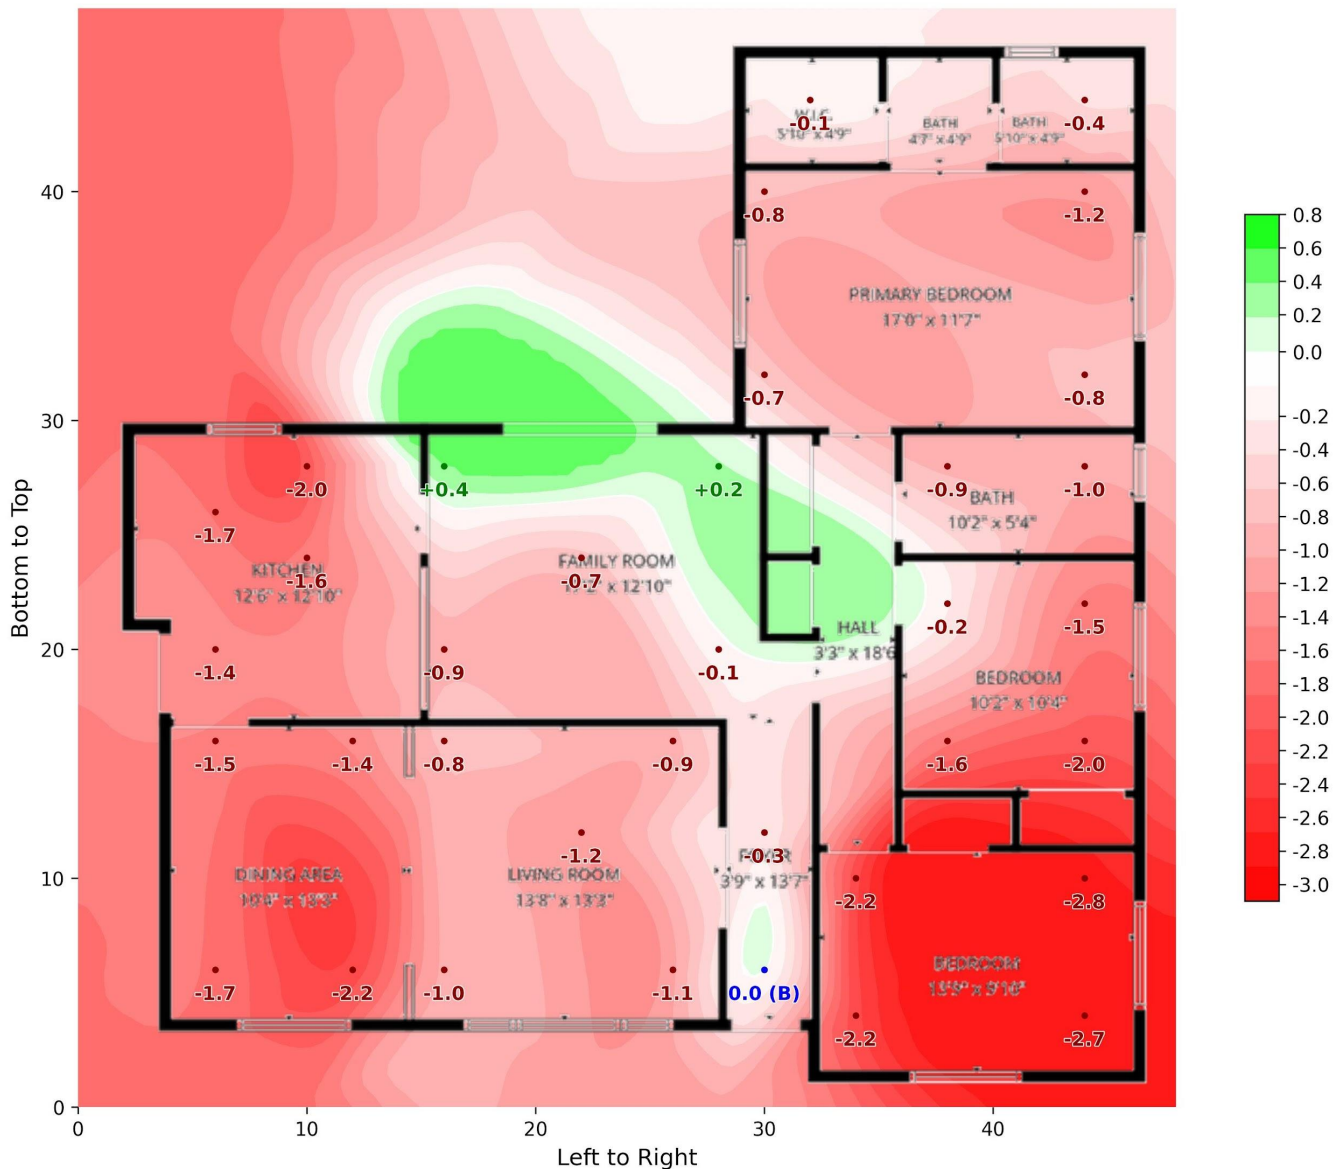
**Elevation Plot Graphic (Figure A)**

The elevation plot resulted in the graphic as depicted above in Figure A. The red-points and areas are elevation measurements that were lower than the base station elevation (0.0). The green-points and areas are elevation measurements that were higher than the base station elevation (0.0). The blue-points (and white areas) are equal to the base station elevation (0.0). The base station is depicted with a (B) symbol. The elevation plot takes into account differences in flooring thicknesses. The maximum elevation point was determined to be 0.4 inches and the minimum was -2.8 inches, resulting in an elevation difference of 3.2 inches of difference across the structure.

Elevation differences across the structure are the first indicator that a foundation problem may or may-not exist. As documented above, the maximum elevation point of this structure was determined to be 0.4 inches and the minimum was -2.8 inches, resulting in an elevation difference of 3.2 inches of difference across the structure. The elevation plot takes into account differences in flooring thicknesses. The elevation deflection across an entire structure should, best-case-scenario, remain within 0.5 to 1-inch depending on the age of the structure. Measured differences approaching 2-inches are an initial sign of possible foundation fatigue. The maximum allowable elevation difference is subjective, depending on other factors such as the visual condition, size, and age of the structure (54 year(s) old) along with how the foundation performs when calculating deflection and tilt.

Based on observed elevations of the foundation from the elevation plot, the elevation differences do not fall within industry standards and tolerable limits. These findings indicate that the foundation does not have consistent and uniform elevation measurements. Note: elevation measurements alone are not the only indicator of foundation issues; see the deflection and tilt calculations (and the report's overall conclusion) for a complete understanding of foundation stabilization. If elevations fall outside of industry standard/tolerable limits, it is a first indicator that the foundation will fail in deflection and/or tilt.

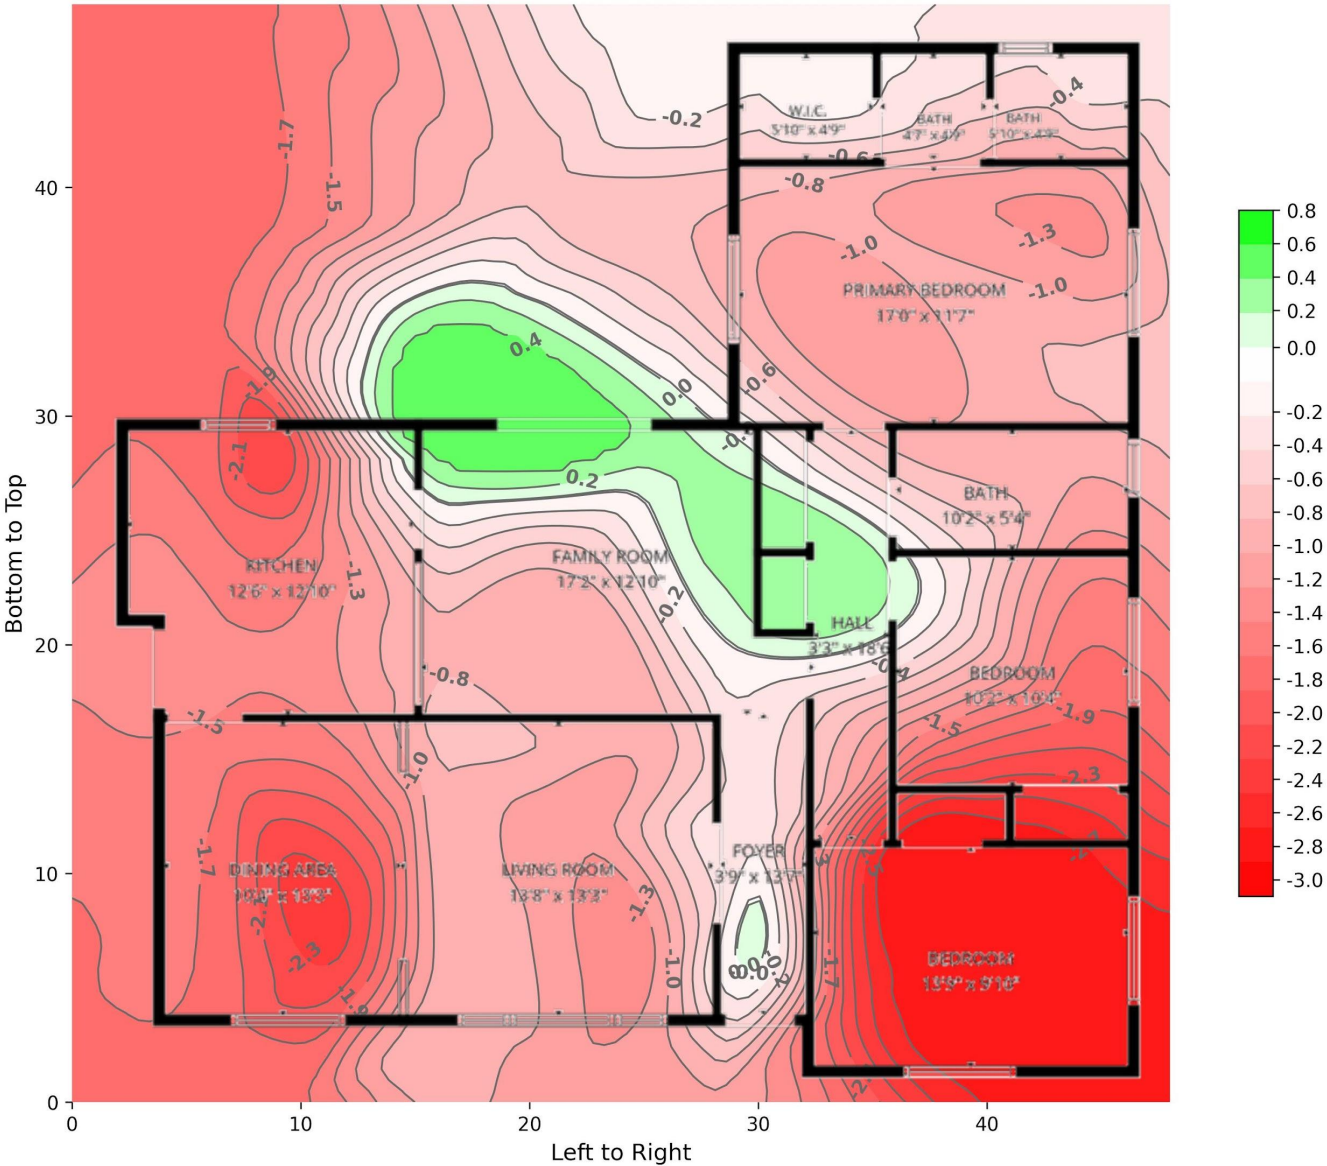
Mesh Contour Graphic (Figure B)

The mesh contours graphic depicted above in Figure B is similar to the elevation plot. The red, green, and white areas depict areas that are lower, higher, and equal to the base station elevation (0.0). The lines or contours (similar to map topography) are labeled at specific intervals.

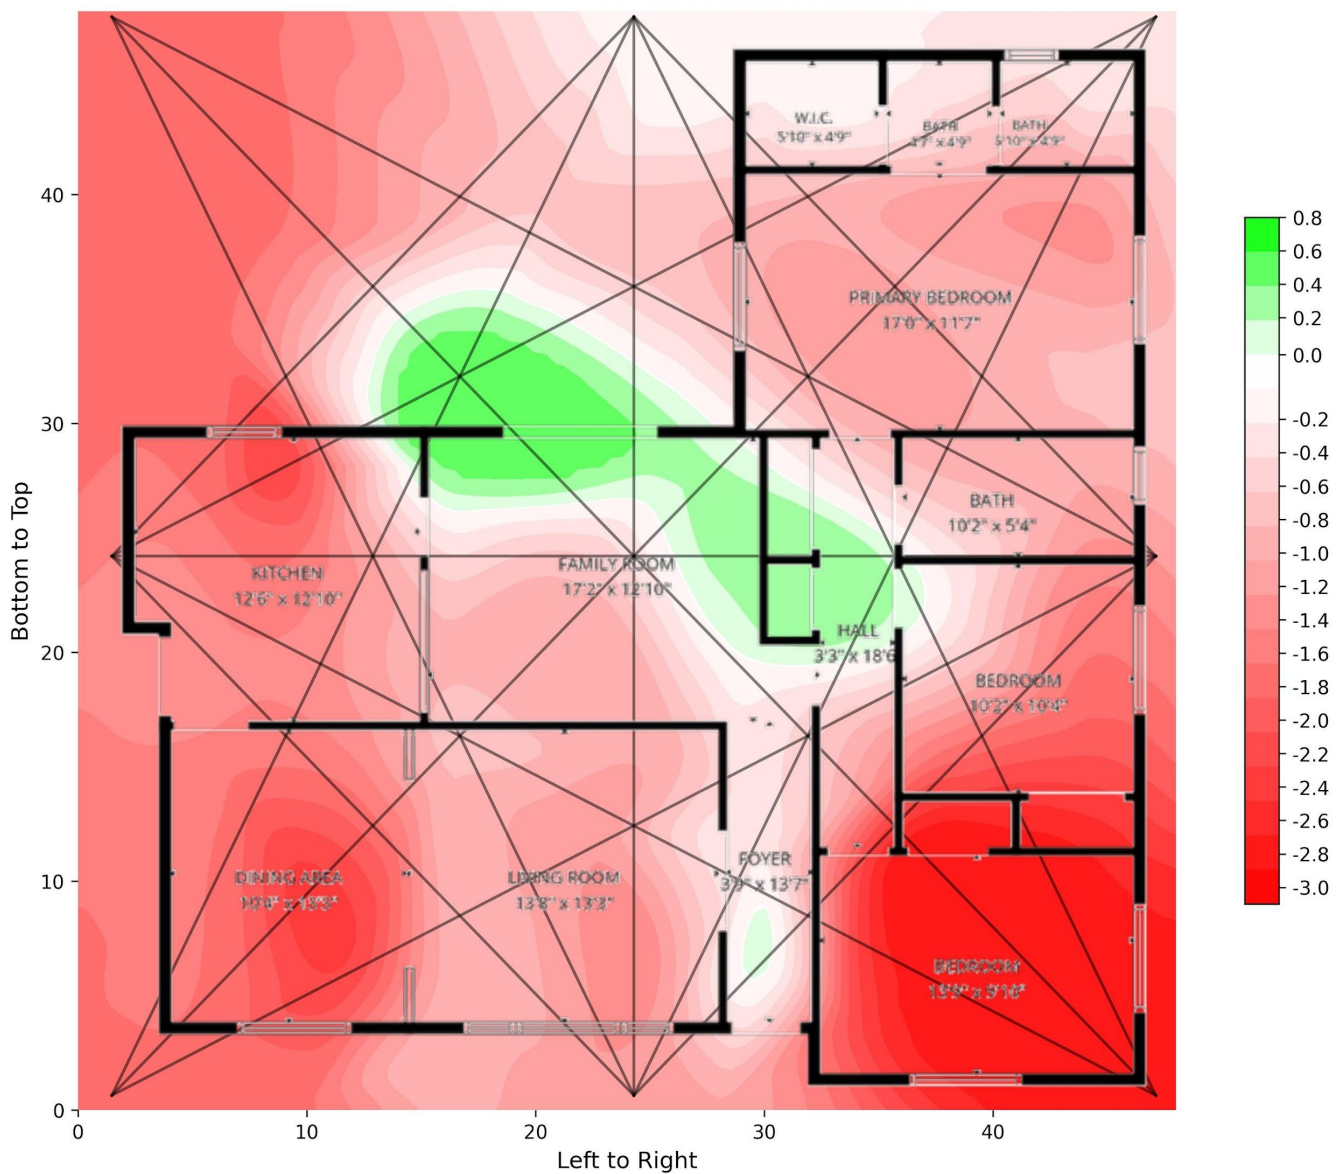
**All Profiles Graphic (Figure C)**

Below is a graphic that shows the locations of deflection and tilt profiles that were calculated. The total profiles calculated was 16 with a total usable profiles (above the effective length threshold) of 16.

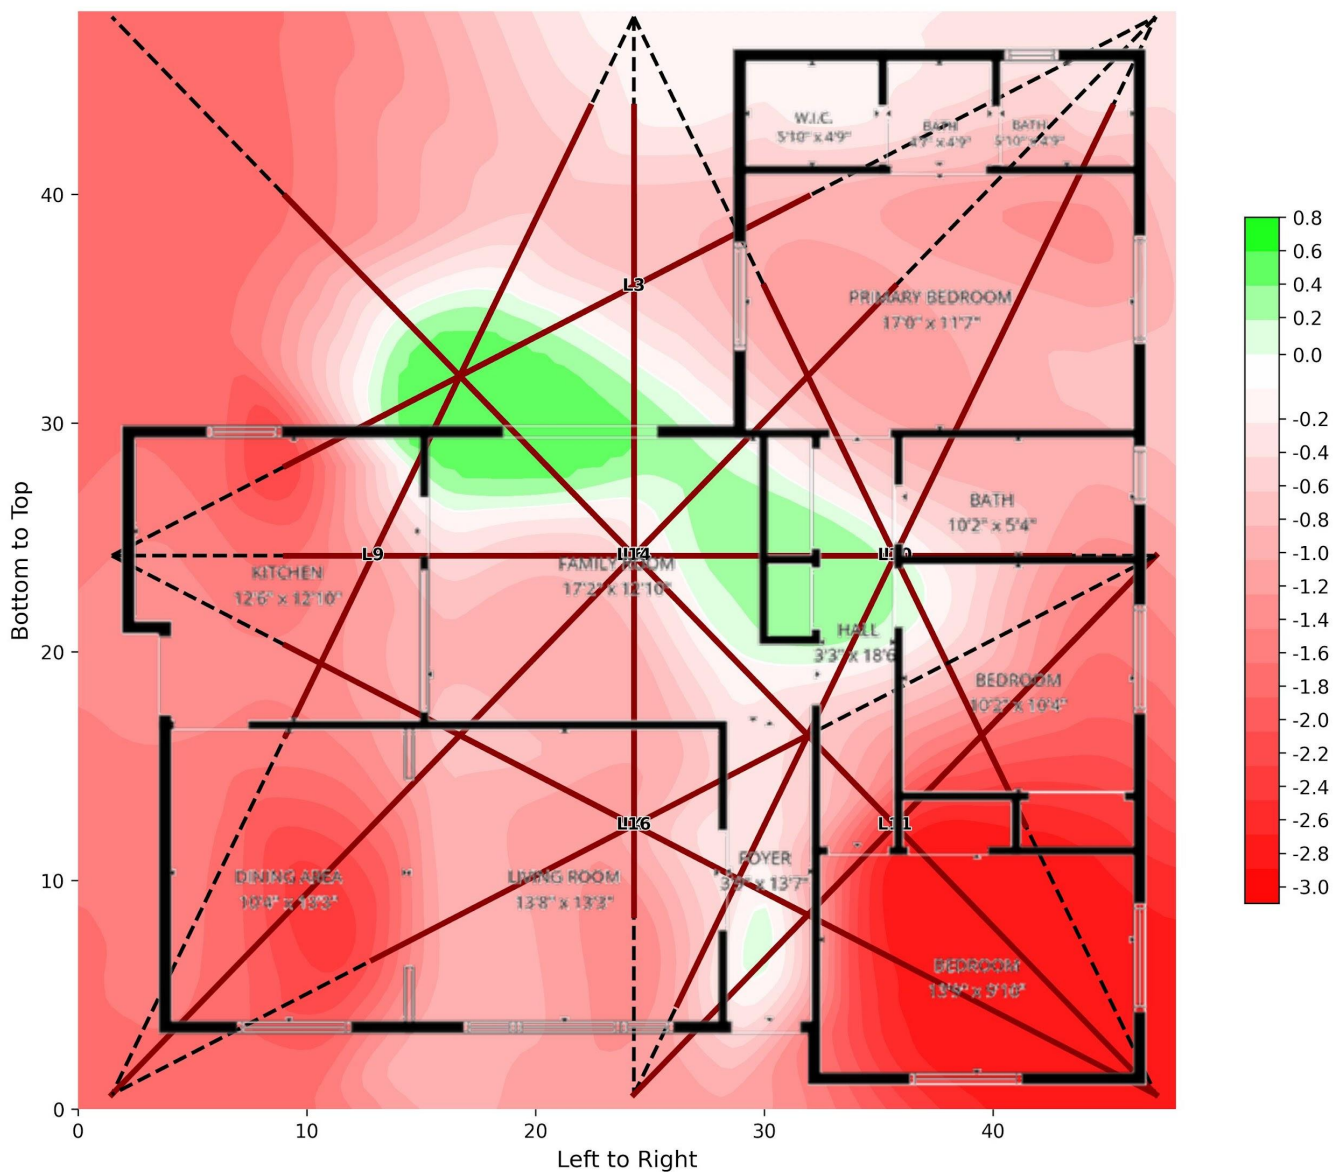
**Deflection Failures Graphic (Figure D)**

Below is a graphic that indicates the locations of the 11 deflection calculation failures.

The above Figure D shows deflection failures along the foundation. Deflection failures can be considered localized failures in (sometimes) isolated portions of the foundation. The profile lines that were calculated are represented by a dashed black line and the areas that the deflection failures occur are represented by a dark red line segment. Of the 16 deflection profiles calculated, 11 profile failures were identified.

Deflection failures can be considered localized failures of the foundation in (sometimes) isolated portions of the foundation. Of the 16 deflection profiles calculated, 11 failures were identified.

Deflection failures are above standard acceptable limits; they exceed industry-standard thresholds and the structure should be considered actively moving/settling in areas where deflection failures are occurring. See the report's overall conclusion for a complete understanding of the overall foundation stabilization issue.

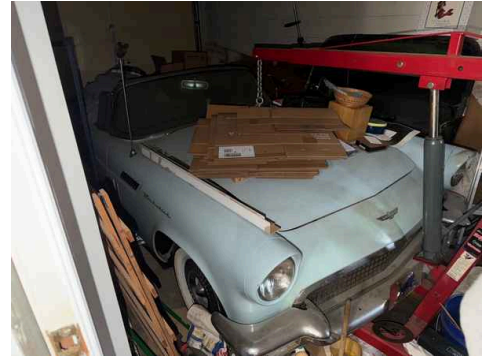
GARAGE

The engineer's foundation evaluation could not be completed due to inaccessibility of the garage foundation area. This limitation prevents a thorough assessment of foundation condition, structural integrity, and potential issues in this location.
