Report V1.0

# Engineer's Foundation Evaluation

On 8/8/2026 a foundation evaluation was performed at the property located at address 5433 Kennerly Rd, Jacksonville, FL, 32207, which consists of a 1540 square-foot single family attached structure built in 1972 (54 years old) with a slab on grade foundation.

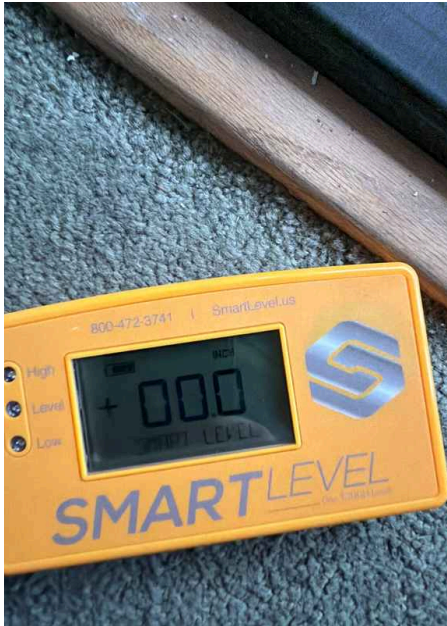
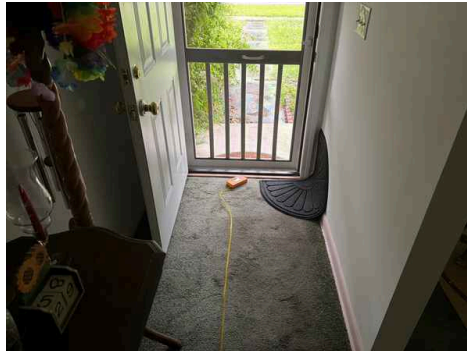
## Base Station: Base station zeroed photo

The base location represents the 0-elevation mark where all other elevation readings are based. The other elevations read from the control panel represent the difference in elevation (in inches) from this base.

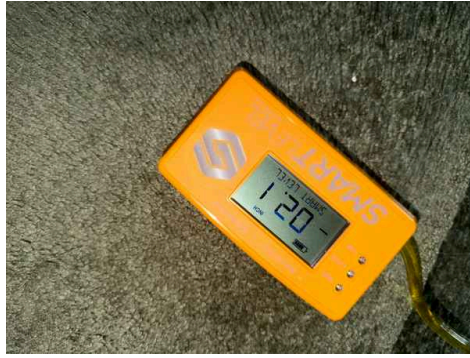
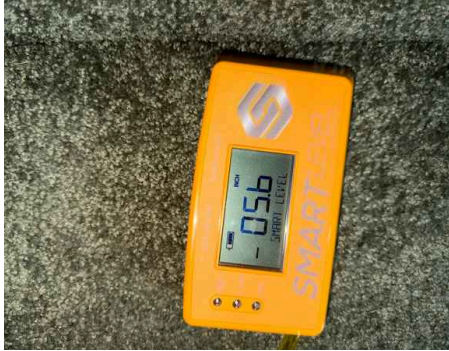
## Family Room: Flooring difference factor

Step down, 3.5

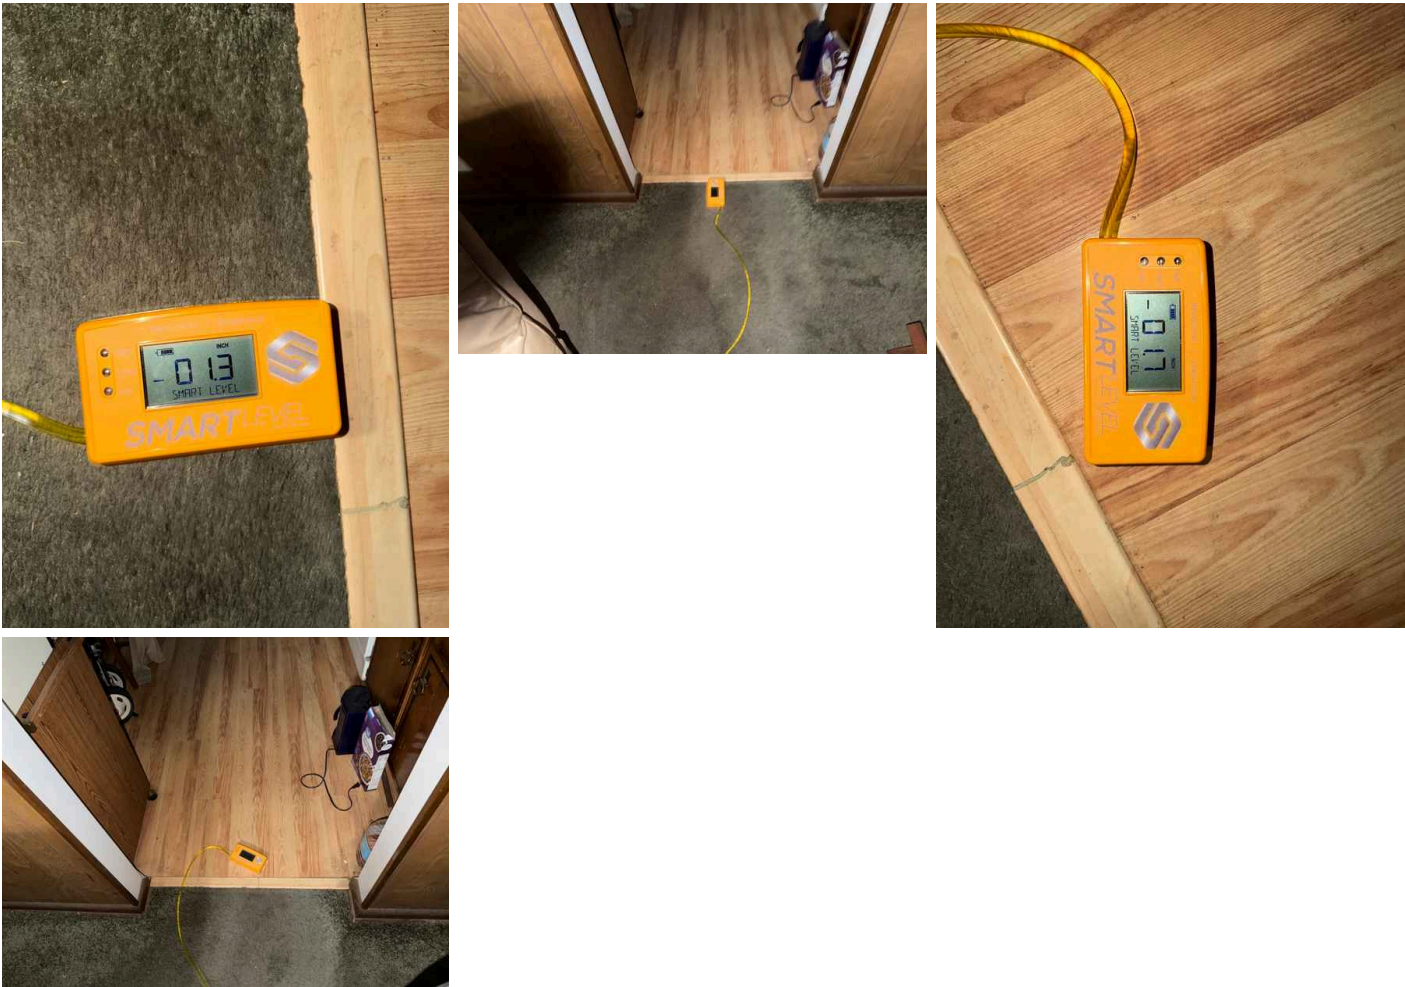
**Kitchen & Nook: Flooring difference factor**

Kitchen  
-0.3"
